# INCREASE OF WEAR RESISTANCE OF THE CRITICAL PARTS OF HYDRAULIC HAMMER BY MEANS OF ION-PLASMA TREATMENT

*D.B. Hlushkova, Yu.V. Ryzhkov, L.L. Kostina, S.V. Demchenko*  
*Kharkov National Automobile and Highway University, Kharkov, Ukraine*  
*E-mail: diana@khadi.kharkov.ua*

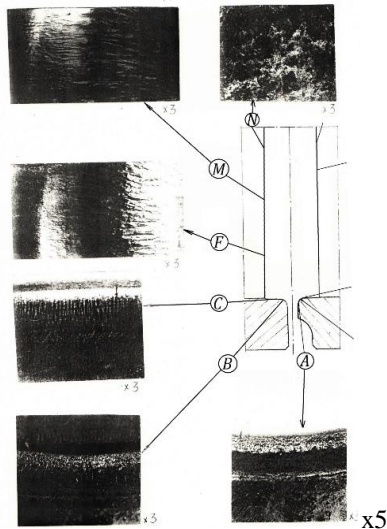
**Wear of parts.** The degree of damage to parts strengthened by means of ion-plasma chromizing using advanced technology is shown on Fig. 2. The initial signs of the coating damage in the form of scoring marks and tearings were detected at the peak in the zones “M” and “F” after 300 loading cycles, on the hammer head in the same zones after 450 cycles.

The scratch marks in the channel cavity of the bush appeared after 600 cycles, of the case after 700 loading cycles. Flaws along the axis of the parts were formed in the channels of the case and the bush (zone “B”) and their cut after 800 cycles. Due to the coating wear of the most loaded sections of the parts the test was stopped after 1730 cycles.

The measurements of the worn parts show that the equivalent diameter of the case and the bush channels in the cut zone increased to 125.5 mm. The hammer head is worn in the zone “N” to 0.2 mm, in the zone “M” to 0.5 mm. Correspondingly the peak – to 0.3 and 0.85 mm. The locations of the greatest wear zones and the nature of the damage to the parts are similar to those observed on the parts examined above.

Fig. 2. Wear of the peak and the bush strengthened by means of ion-plasma chromizing (using advanced technology), x5

The damage nature of the hammer head and the peak is identical to the observed one on the parts tested earlier, strengthened by means of ion-plasma chromizing using initial technology. Smoothed spot is detected in the central section of the hammered head (zone "N"). The coating is less worn on the hammer head, than on the peak. There is a pattern of valley-tearing developed more on the peak in the zone "M".

The pattern of valleys on the hammer head is significantly smoothed in the result of the wear. It is specified that the hammer head and the peak differ less as for the extent of valleys development than the hammer head and the peak of the strengthening variants tested earlier. Zone "F" is characterized with coating wear, wear hardening and smooth surface. The damage in this zone is even on the circle of the parts and practically identical on the hammer head and the peak.

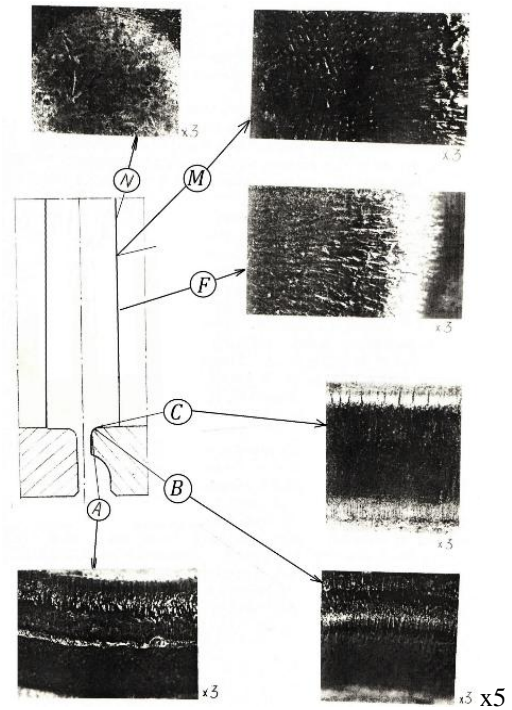
Wear hardening and metal plastic working are observed in the zone “A” of the hammer head channel (the case) and the bush (Fig. 3). These effects are more intensive on the bush. The wear, surface coating plastic working and the formation of valley-tearing are seen in the zone “B”. The valley tops are smoothed, worn (to the base on some sections) on the bush, the valleys are rough, without wear features on the case. Even wear, wear hardening and surface coating scaling are observed in the zone “B”. The scaling on the case is major, on the

bus is in the initial stage of the development. The small sections of remained strengthened layer are recognized on the case. The surfaces of zone "D" are characterized with artificial aging and scaling of the material. Coating wear on the case and the bush goes without signs of chipping or peeling.

Fig. 3. Wear of the case and the hammer head, strengthened by means of ion-plasma chromizing (using advanced technology), x5

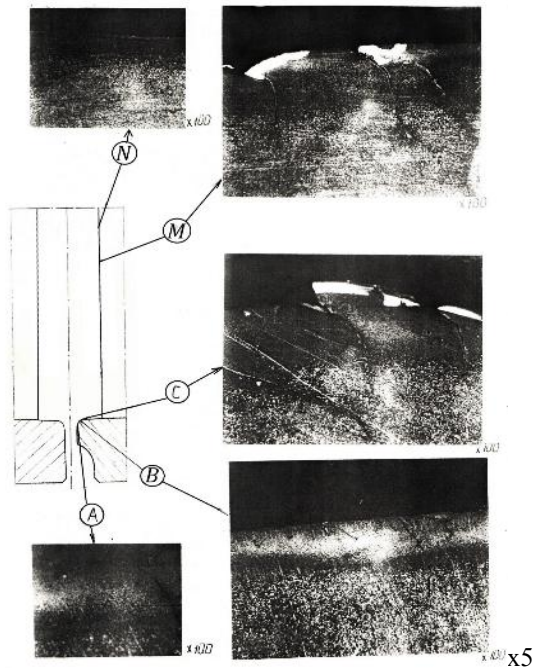
Flaws on the case and the bush are observed in the zones "A" and "B". Their depth on the case reaches 0.55 mm, on the bush 0.4 mm. There are no flaws in the zones "C" and "D". Flaws on the hammer head are found in the zone "N" of 0.3 mm depth and in the zone "M" – up to 0.6 mm. There are flaws on the peak only in the zone "M" of 0.6 depth.

The structural changes are observed in the metal of the examined parts in the damage areas. The structural changes for the depth 0.25...0.30 mm on the bush are indicated in the zones "A" and "B". The hardness of material in the structural changes zones is HV 510...645.

Fig. 4. Structural changes of the material of the case and the hammer head strengthened by means of ion-plasma chromizing (using advanced technology), x5

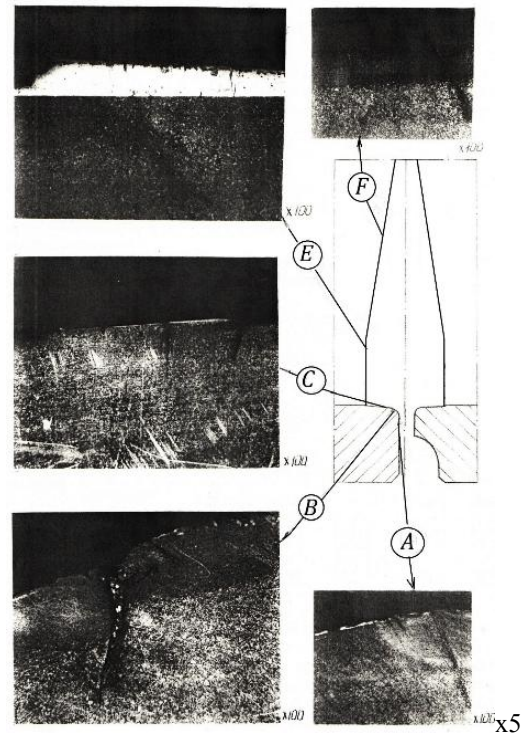
The structural changes for the depth 0.25...0.30 mm are observed in the zones "N" and "M" on the peak material. On the hammer head in the same zones the depth of the structural changes is 0.15...0.20 mm. The hardness of material in the structural changes zones is HV 510...585. The hardness of the material of the examined parts: the bush – HRC 40...42; the peak – HRC 40...42; the case – HRC 40...42; hammer head – HRC 40...42.

Fig. 5. Structural changes of the material of the peak and the bush strengthened by means of ion-plasma chromizing (using advanced technology), x5
