## Failure Analysis of a Heavy Duty Gas Turbine Blade\*

S. Asadikouhanjani,<sup>1</sup> M. Torfeh, and R. Ghorbanf

Mapna Turbine Blade Engineering & Manufacturing Company, Iran

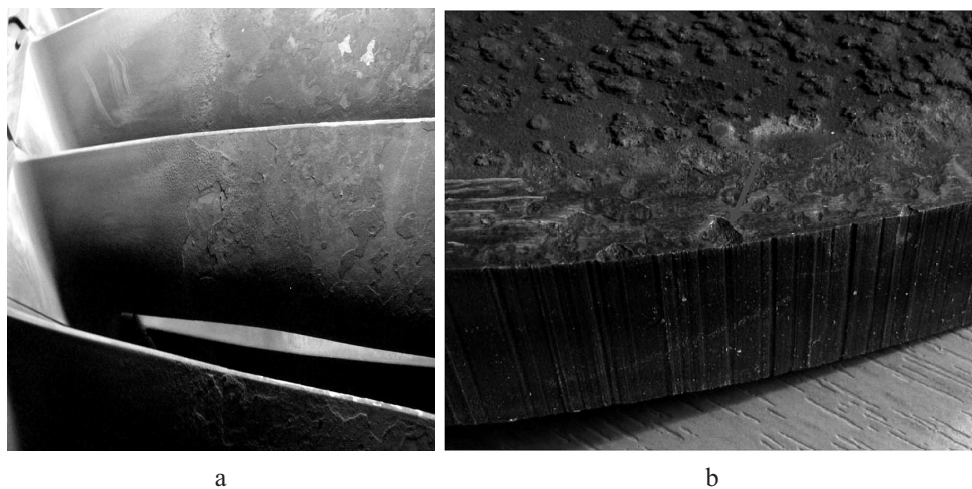
**Visual Examination.** The as-received blades are shown in Fig. 1a. The surface of the blades exhibited deterioration or signs of corrosion, and many deposits can be seen on them. The deposits can be removed easily and underneath of them there are many pits at the surface of the blades (Fig. 1b). Consequently, the surface of the blade was uneven and rugged, and base metal of the blade appeared to be damaged and/or missing in several areas.

Fig. 1. Overview of the damaged blades (a); existence of pits underneath of deposits (b).

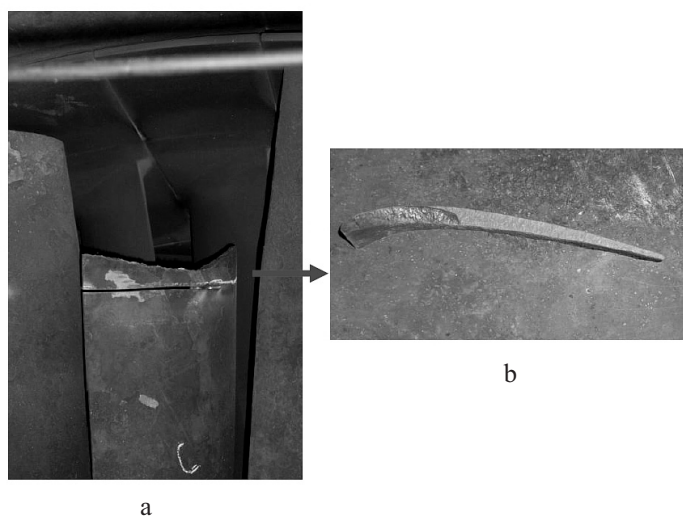
Furthermore visual evaluations revealed that one of the blades was cut off at 12 cm from tip, about two-third of the airfoil span (Fig. 2a), showed fatigue marks at the fracture surface, which is presented in Fig. 2b. So, a series of analysis were performed on this blade to identify the possible cause of failure. Moreover, the detached piece of the blade had caused some damage to other blades and the exhaust inner wall.

Fig. 2. Broken blade (a); fracture surface of the broken blade with fatigue marks (b).

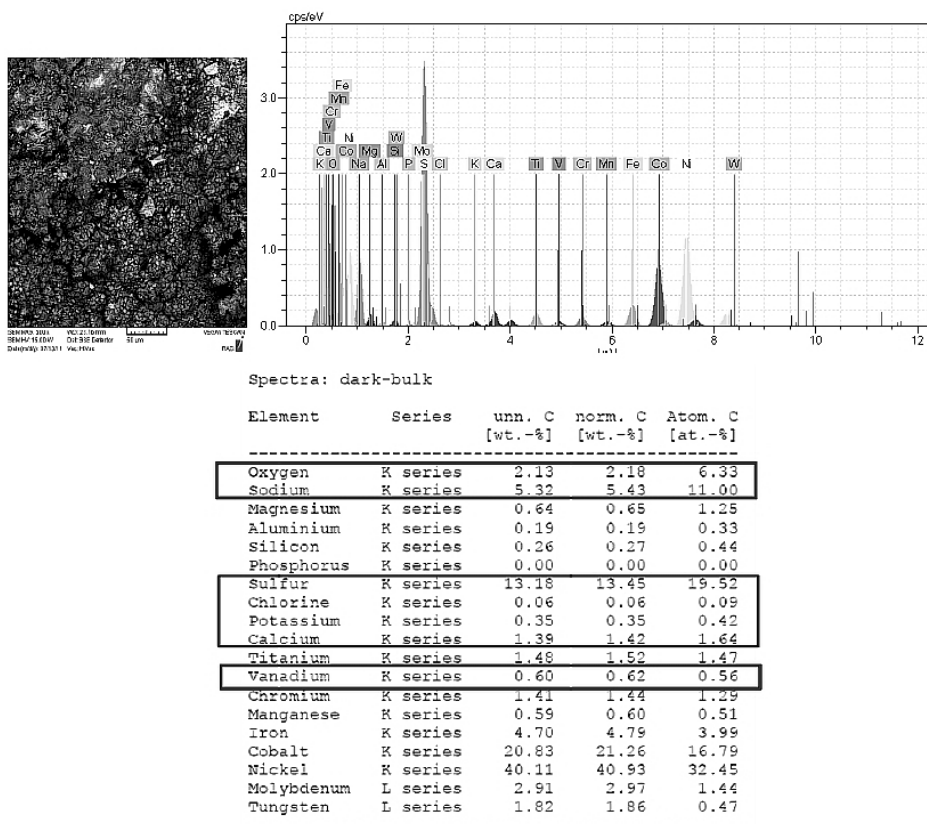
Fig. 3. Chemical composition of the deposits.

Fig. 3, EDS analysis of deposit revealed that its components contained several percents of S, Na, Ca, O, and V, as contaminant elements (probably in the form of corrosive components of  $\text{Na}_2\text{SO}_4$  and  $\text{V}_2\text{O}_5$ ). Existence of these components makes the blade susceptible to occurrence of hot corrosion of types I and II.

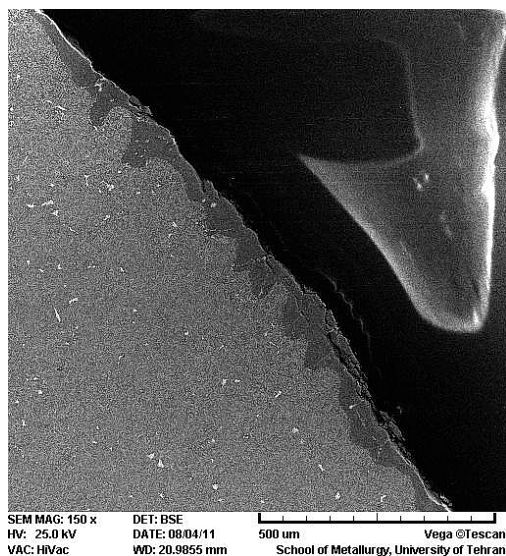
A typical cross-sectional microstructure of severely corroded part is shown in Fig. 4. A layer type of hot corrosion with an uneven scale base metal interface without any subscale sulphides and precipitate-depleted zones was found to be present. According to results of visual examination, chemical and metallographic analysis, type II of hot corrosion is an active damaging mechanism in this turbine.

Fig. 4. SEM micrograph of the corroded blade material.

4. In order to prevent the hot corrosion, the air and fuel filter should be reinforced, and CoCrAlYRe (VPS) or NiCoCrAlY (VPS) coating with higher anticorrosive properties should be used over the surface of the blade.

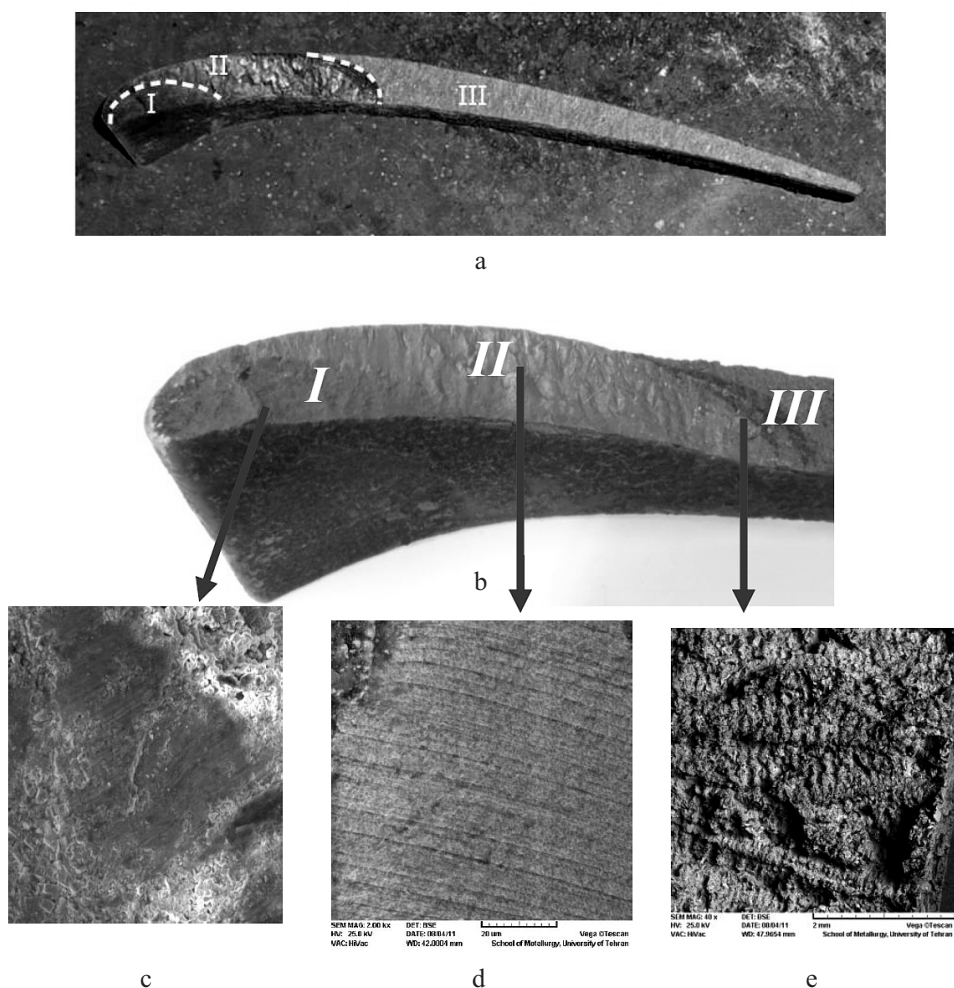
**Fractographic Analysis.** The upper view of the broken blade is presented in Fig. 5a. The general orientation of the fracture surface is nearly  $45^\circ$  to the longitudinal axis of the blade (Fig. 5b). Three distinct regions denoted by *I*, *II*, and *III* in Fig. 5a can be identified at the fracture surface. Visual examination clearly showed the typical fatigue fracture surface with a propagation area and a final fracture zone (Fig. 5a). The fracture mechanism in three regions is analyzed by SEM. Details of the fracture surface are shown in Fig. 5c–e. Region *I* shows a dark fracture surface. EDS analysis of the fracture surface in this region revealed the presence of S, Na, O as corrosive elements. In addition, some isolated typical fatigue striations could be identified in region *I*. In fact, the fracture surface of region *I* was corroded by some components like  $\text{Na}_2\text{SO}_4$ , or a mixed mode of fatigue-hot corrosion mechanism seems to occur. Details of the fracture surface of region *II* shows sharp fatigue striations (Fig. 5d). In regions *I* and *II*, the crack propagation occurred in the pressure-suction side direction. Region *III* reveals a rough dendritic fracture surface. This is the sign of a final fracture because of the overload.

Fig. 5. General view of the fracture surface (a); higher magnification of three regions (b); presence of striations and corrosion products in region I (c); presence of striation in region II (d); dendritic fracture surface in region III (e).
