## In-Service Fatigue Fracture Mechanisms in Covered Disks of a TV3-117VK Helicopter Turbine Engine

*In-service propagating fatigue cracks were examined in EI-698VD superalloy thin turbine covered disks of the first, second, and third stages of a TV3-117VK helicopter engine within service lifes of 200–1800 h. To reveal causes of early crack initiation and estimate a propagation time, metallographic and fractographic analyses were performed. The sequence of events during fatigue cracking of the disks was established. A block of striations on the fracture surface was discovered, which characterized fatigue crack propagation during one flight of a helicopter under different operating conditions. The number of striations in each block varied over the range of 4–20, being much more than those used to design covered disks. Fractographic results were used to estimate fatigue crack growth in covered disks of different stages using data on different operating conditions of helicopters.*

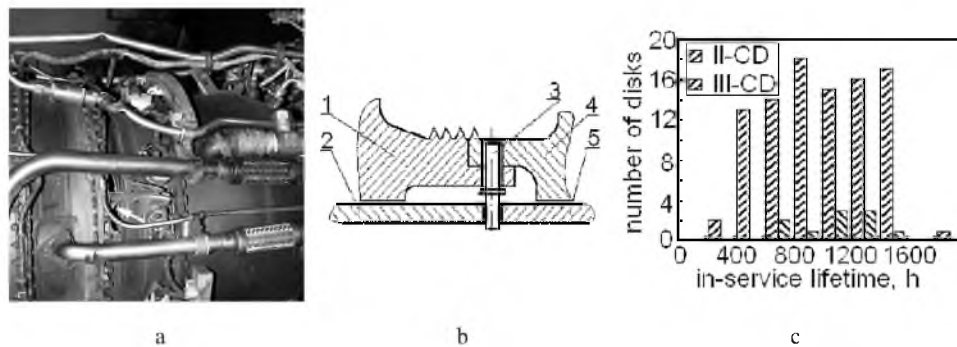
The examination of the engine revealed a hole on the top of its right part caused by the body fracture (Fig. 1). The fracture zone was located in the vicinity of II covered disk (CD) of the turbine compressor (TC) [2].

**Research Procedure.** The in-service cracked CDs of the TC II and III stages of a TV3-117 engine were statistically analyzed. The analysis has shown that crack initiation in CDs occurred near the hole 3.6 mm in diameter (Fig. 1), used to position CDs. Cracks propagating from the hole in the II CD appeared after about 300 h (Fig. 1c). Cracks were regularly observed after in-service time of more than 400 h. The number of cracked (not failed) disks increased with time. First cases of III CDs cracking were registered within 600–800 h. The replacement of the III CDs during repair demonstrates the absence of correlation between the number of cracks and time in service.

Fig. 1. Overview of a TV3-117VK engine area with the failed zone (a); scheme of the TK of a TV3-117 engine in the vicinity of a hole (b) with pin (3) of the II (1) and III (4) CDs of the II (2) and III (5) TC stages, and the number of cracked disks vs. in-service lifetime for the II and III CDs (c).

(i) crack propagation in the outward direction initiated from one or several origins located near the hole (Fig. 1);

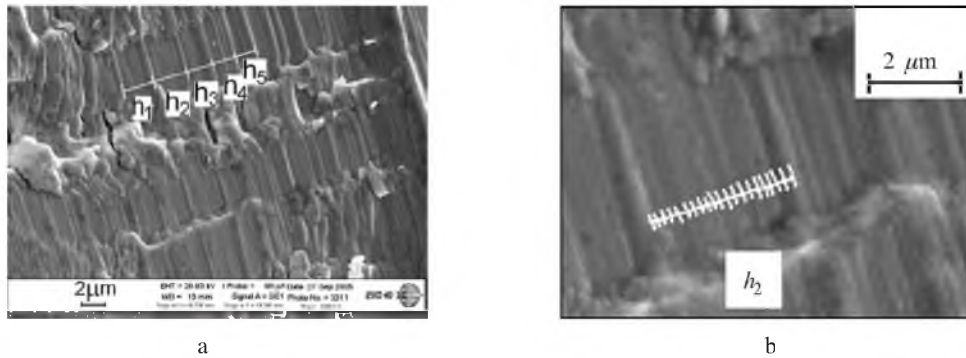
(ii) on the fracture surface, not far from an origin, striations were observed and they represented the block of finer striations within 4–20 (Fig. 2);

(v) crack propagation in the I CDs occurred from several holes, and blocks of fatigue striations, detected on the fracture surfaces, were similar to those in the II CD (Fig. 2);

Fig. 2. Blocks (a) of striations  $h_i$  in fatigue fracture surface of the I-CD of the in-flight failed engine and (b) 21 striations in one of these blocks.

Thus, CD fatigue cracking occurred in a low-cycle fatigue range. The difference in the number of striations in each block reflects the difference in the number of events determined by operating conditions of each flight. This problem was discussed earlier [2]. The same pattern was observed on a strip-chart, which registered in-flight power variations during wood transportation. This fragment, represented a sequence of 21 cycles of power variations as a result of helicopter height variations.

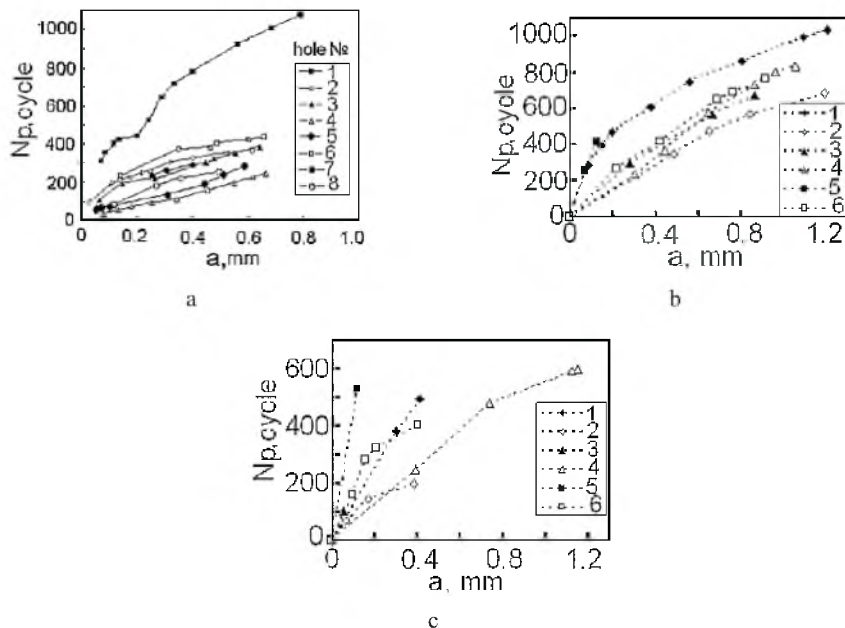
Therefore, each block of striations was considered as a crack increment during one flight. Based on this correlation, fatigue crack growth was estimated in terms of the number of flights for all CDs (Fig. 3).

Fig. 3. Number of flights,  $N_p$ , vs. crack length,  $a$ , for the I-CD in the inward direction (a) and for the II-CD after 1057 h in the outward (b) and inward (c) directions. Holes are indicated by numbers.

1) cracks in II CDs originate after minimum 180 flights and their propagation in both directions from any hole occurs as follows: a crack initiates and grows in the outward direction, and further after certain delay, a crack propagates inward;

2) in the II CDs, the onset of crack propagation inward occurred after a crack propagating outward after minimum 170 flights.

The minimum duration of the main crack growth to the moment of the catastrophic fracture of the II CD was  $450+420=870$  flights. The total time in service of the disk includes periods of crack initiation and propagation in two directions and is the sum  $180+170+870=1220$  flights.

Thus, fatigue cracks in the I and II CDs took place after the last repair, but were not detected. The change of loading conditions for the I CD at the crack depth of about 0.2 mm was due to its rearrangement during repair (see Fig. 3a, hole No. 1).

It is recommended to improve non-destructive testing of CDs during their repair to reveal cracks of a length of 0.1–0.3 mm in depth that could not be detected on the disk side-surface.
