The analysis of the defects on the surface of galvanized steel structures

Lie-long Wang, Liang-liang Zhou

Some black spots were found on the surface GA products, which could not meet the requirements of production of outside panel of automobile. The cause of the defects was investigated. Methods of their elimination are suggested.

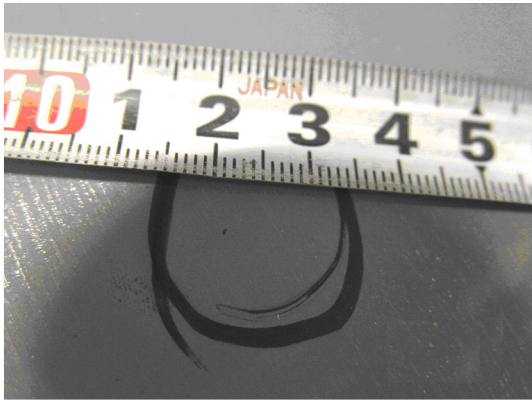
The defect is dotted with black color. From the macroscopic surface, the point defects extend along the rolling direction, which indicates that the black material adhered to the steel plate and produced a certain degree of deformation(in Fig.1).

Fig. 1 Macro morphology of the black spot defects

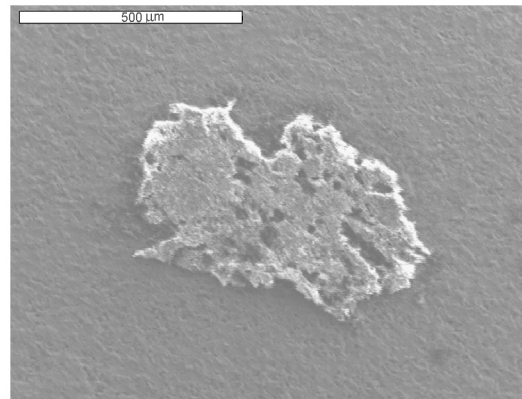
Using SEM observation (in Fig 2), the surface of the defect has a rolling mark. The phenomenon of charge accumulation at the defect under the charge bombardment is shown.

Fig. 2 The SEM observation of the black spot

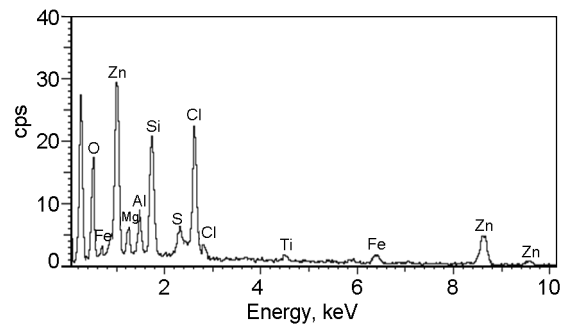
EPMA analysis of the chemical composition of defects (in Fig 3), found that it is mainly composed of C, O, Cl and other elements, the chemical composition of rubber, the rest of the small amount of Mg, S, Si as the composition of rubber additives. Effect of Zn and Fe on the alloy galvanized sheet. Therefore, the black spot defect can be judged to be caused by the pressure of rubber particles.

Fig. 3 The chemical composition of the black spot defect

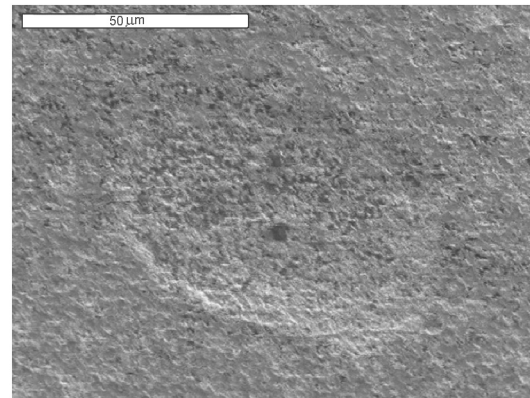
In order to further judge the defect position in the production line, with alcohol will erase the rubber particles (in Fig 4), found that the defect area produces a pit, shows that the highly compacted role, and the surface electrical discharge texturing (roller printing machine working roller surface morphology after treatment with EDT).

Fig. 4 The SEM morphology of the defect area after removing rubber powder using alcohol

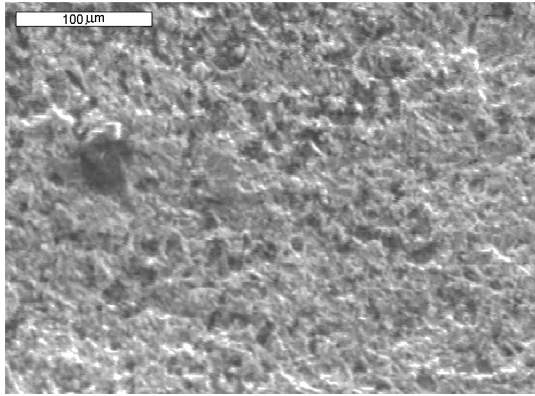
Furthermore, the morphology of the region was observed by high magnification (in Fig 5), and no roll print was found on the SEM.

Fig. 5 The SEM observation of black spot area after removing rubber spot, and no skin level rolling marks were found.

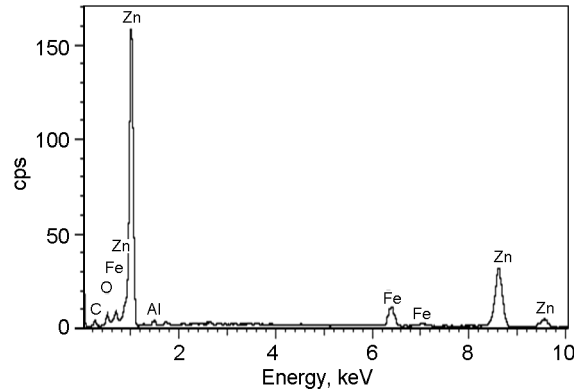
The composition analysis of the flaws removed area (in Fig 6), which mainly consisting of iron, zinc, quantitative analysis results: Fe = 10.2%; Zn = 89.8%, normal tissue zinc alloying layer, indicating the defects in normal after alloying annealing.

Fig. 6 The chemical composition of the black spot defect area after removing rubber powder, and the chemical elements includes iron and zinc, which is the normal composition of GA coating.
