# TRIUMF CYCLOTRON RF SYSTEM RELIABILITY ENHANCEMENT

Yu. Bylinsky, S. Calic, G. Dutto, K. Fong, R. Poirier TRIUMF, 4004 Wesbrook Mall, Vancouver, V6T 2A3, Canada; E-mail: bylinsky@triumf.ca

This paper presents recent RF system improvements related to the cyclotron resonators, RF amplifiers, and transmission lines. Although the program is not complete, the downtime due to rf sparking has already been reduced by a factor of 5.

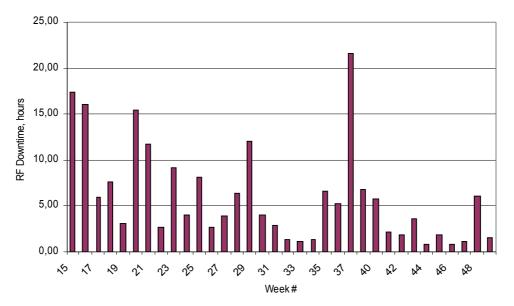
tip tuning to reduce the leakage field. As a result, the cyclotron downtime due to sparking was lowered by a factor of 5. The weekly downtime graph is presented in Figure.

Year 2002 weekly rf downtime graph. GAT system was upgraded on week 41

probes, installed on the resonator panels. So the leakage field level can be adjusted and minimized by varying the rf gap between ground arms and hot arms. After the new refurbished control system for the ground arm tip (GAT) position was installed, we performed extensive
