RESEARCH OF THE STATE OF INTERNAL SURFACES OF A SUPERCRITICAL WATER LOOP AFTER A SESSION OF IRRADIATION

Made of austenitic steel at the NSC KIPT, the supercritical water convection loop Loop-1a was running for more than 500 hours in the first experimental session (in 2011). The materials tested in the loop were placed into a stream of water (more than 50 g/s) at a temperature of 350...400°C, a pressure of 23...25 MPa, and were irradiated by an electron beam with an energy of 10 MeV. Sediments that emerged on the inner surface of the loop were examined. The sediment mainly consisted of compounds of calcium and iron mixed with other elements. There is a possibility to increase corrosion induced by radiation due to dislocation damage, hydrogenation of metal and under the impact of active oxygen.

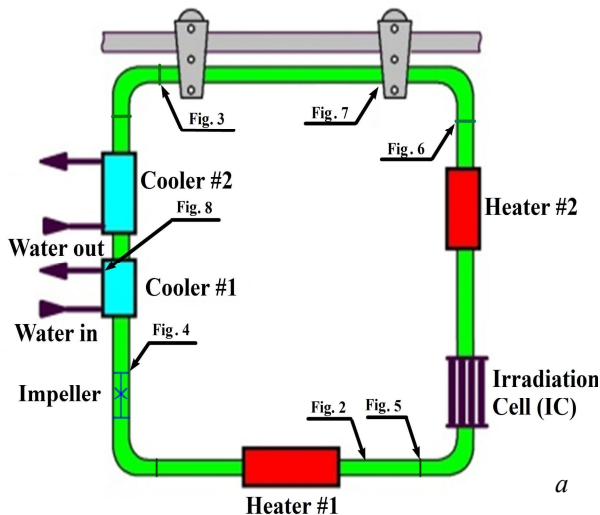
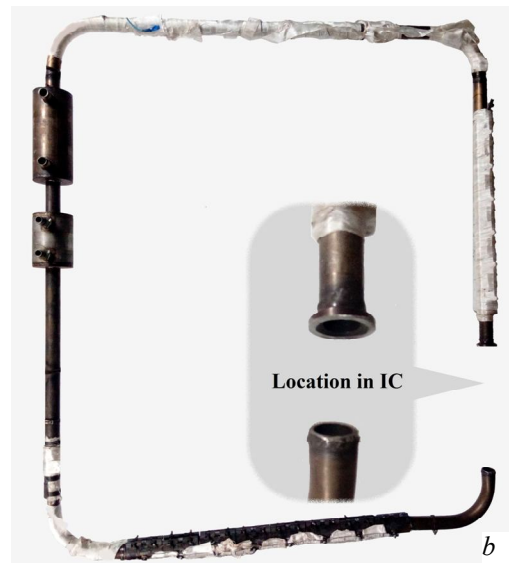
In the first session, the Loop-1a was running for more than 500 h [3, 5]. After the session, the irradiation chamber (IC) was dismantled from the loop. The scheme of the loop with the cut out IC is shown in Fig. 1.

Fig. 1. Supercritical water convection loop. The scheme of the loop (a); photos inside the loop (b)

Using a miniature video camera, was shot a video of the inner surface of the loop pipe. Fig. 1 shows the location where the photos was taken inside the loop. The pipe is mainly covered by whitish sediment, which consists of grains of calcium salts (Fig. 2).

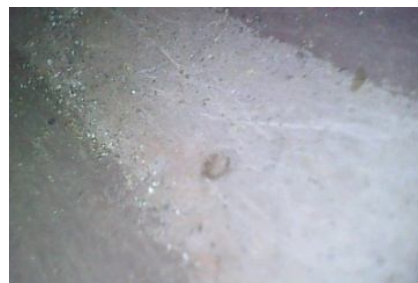
Fig. 2. Sediments on the inner surface of the pipe (lower, horizontal part), grains of calcium salts are visible

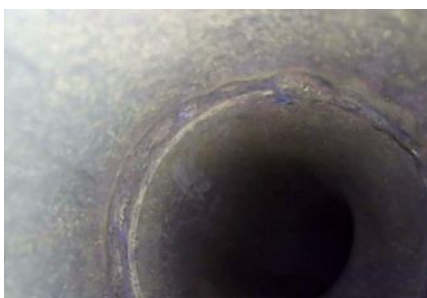
A light lilac color coating is observed on the annular welding seam (Fig. 3). Samples of sediment were taken from the inner surfaces of the loop, it was possible to collect part of the coating (sediment) at a distance of 15 and 60 cm from IC, to the right and left of heater № 1, as well as from the blue ring on the weld (see Fig. 3).

As can be seen from the Table, a significant calcium content was found, as well as a noticeable content of heavy metals and strontium as a satellite of calcium. In the sample taken from the place of ring welding (see a blue ring, sample № 3, Fig. 3), an increased content of iron, nickel, copper and chromium was determined, which may indicate an increase of corrosion along the weld. The content of phosphorus in the sample (up to 0.5%) confirms that corrosion of stainless steel occurs in SCW.

Fig. 3. The blue ring where sample № 3 is taken. A strip of rust and a nearby bluish strip are located asymmetrically along the diameter of the annular seam

Most sediment inside the loop is non-corrosive, and rust spots and colored sediment indicate corrosion of stainless steel. At the welds, an increased amount of sediment is observed. Blue sediment is characterized by high content of iron, chromium, copper, nickel. In the area of the heater, the sediment layer is uneven.

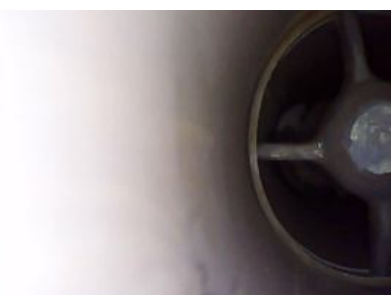
Fig. 4. Sediments on the impeller

Experiment 2019 showed that sediment on the impeller swirling the SCR flow is more dense (Fig. 4) than on the straight pipe section (Fig. 7); in the heater region, the sediment layer is inhomogeneous (Fig. 5), above the irradiation chamber dense sediment (Fig. 6), yellowish lamellar sediment from recycled water in the cooler is the same as in the first session, and characterized by a high content of strontium (Fig. 8).

Sediment on the impeller is of the same type as on the straight section of the pipe, but it is more dense in appearance.

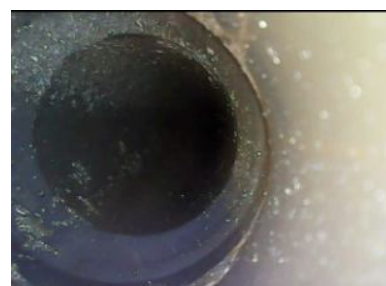
Fig. 5. The beginning of the pipe under the lower heater, the sediment layer is loose, pimples are visible

Below the irradiation chamber, sediment is loose (see Fig. 5), and above the chamber sediment is more smooth and denser (see Fig. 6). It is possible that phase transitions of the water in IC from before critical state to supercritical state and vice versa, contributes to compaction of sediment on the pipe. To clarify this statement, additional research is required.

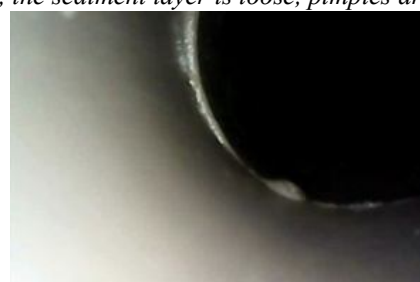
Fig. 6. The seam above the IC, dense sediments are mostly whitish

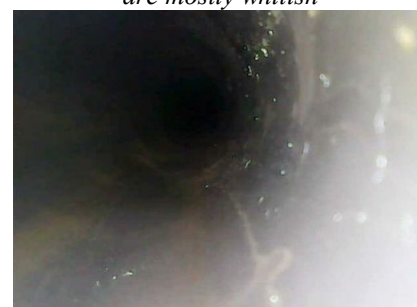
Fig. 7. Upper horizontal pipe

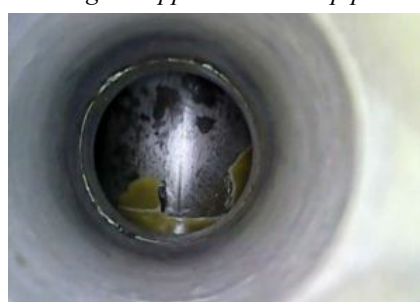
Fig. 8. The output of water from the cooler 1

Sediment in the cooler from recycled water (see Fig. 8) is characterized by a high strontium content, even slightly higher than the calcium content. That can be explained by the lower solubility of strontium salts.
