Experimental study on full-penetration friction stir welding of 2219 aluminum alloy

This paper takes 2219 aluminum alloy as the object of study, makes an experiment of full-penetration friction stir welding (FSW). The effectiveness of three kinds of full penetration procedure are verified by using technology of X-ray flaw test and root color test, and the differences of mechanical property of weld bead of three FSW have been analyzed based on mechanical property and metallographic tests. Through the experiment, the FSW of back supporting can be proved to be the most suitable welding procedure for production.

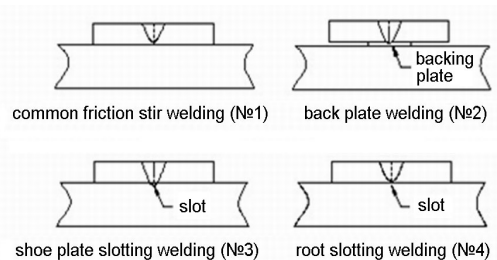
Fig. 1. A sketch map of four kinds of friction stir welding.

Four pairs of samples are chosen for the full penetration test. The common friction stir welding (FSW) procedure, the back plate welding procedure, the shoe plate slotting welding procedure and the root slotting welding procedure are used respectively. As shown in Fig. (1), they are marked as 1#, 2#, 3# and 4#, respectively.

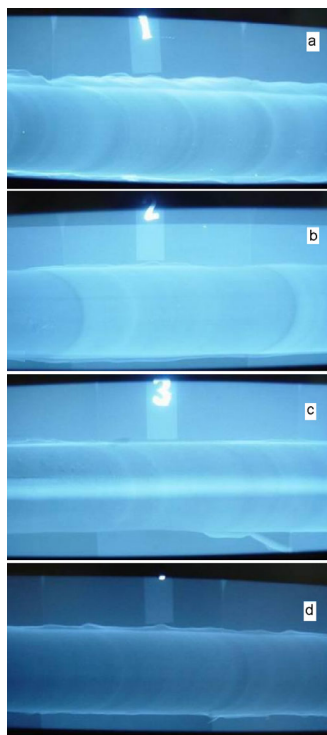
Fig. 2 Radiographic inspection photos of specimens.

In order to understand the welding penetration of four kinds of friction stir welding procedure, radiographic inspection and root coloring test for four welding samples are carried out [8]. Figs. 2 a-d is №1-4 radiographic inspection photos. We can see that there is no incomplete penetration defect in radiographic inspection. One white thick line in the photo of №3 specimen is the position of the groove.

The results of radiographic and root coloring tests show that the three types of fully penetrated friction stir welding proce-

sure can ensure the weld bead to be fully penetrated in the range of 0.8 mm size deviation, and meet the nondestructive testing requirements of the friction stir welds in the annular joint.

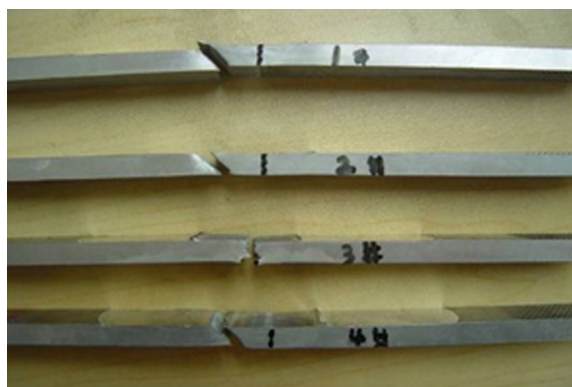
Fig. 4. Fracture position of the specimens.

Fig. 4 shows the fracture position of the tensile test of four specimens, of which the fracture position of the №1, №2 and №4 specimens are the position of the back side of the weld bead, the shear angle is 45 degrees, and the fracture position of the №3 specimen is the fracture at the bead of the original root. The black line in the picture is the original weld position [9].

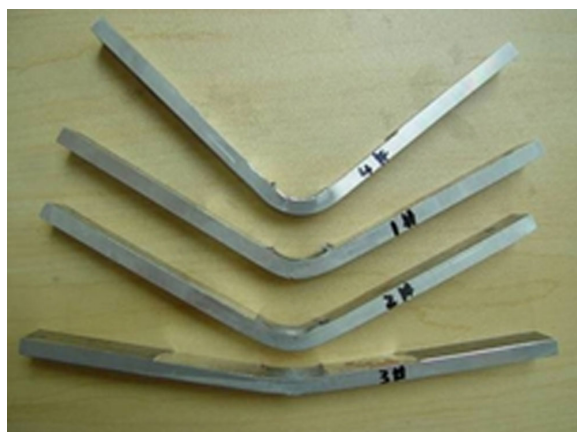
Fig. 5. Root bending test result of specimens.

connected or loose. Table 3 is the bending angle for the root of weld joint of the samples. It can be seen that the bending angle of №3 specimen is the smallest, 17 degrees, the maximum angle of №4 specimen is 97 degrees, №1 and №2 specimens are around 55 degrees. Fig. 5 is a material object photograph of four bending specimens. Among them, the crack initiation position of №3 is the original root weld, and it is straight crack along the position of the original weld. The №1, №2 and №4 cracks are not at the original weld position.

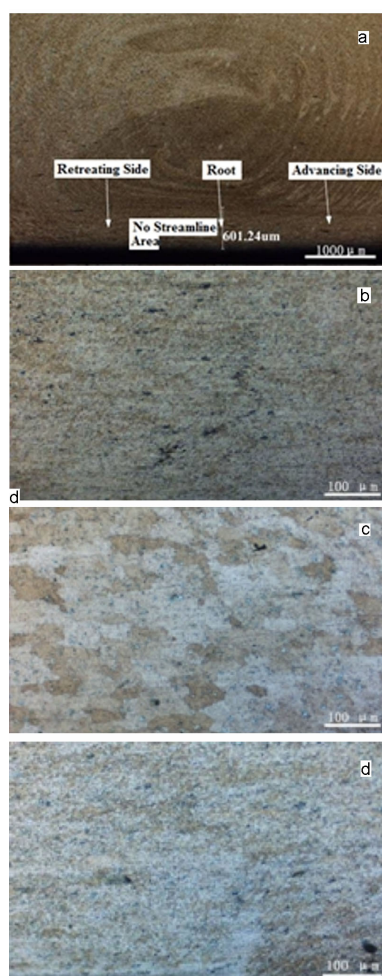
Fig. 6 is a metallographic photograph of the root of weld for specimen №1. The microstructure of weld root belongs to the nugget area [12]. From Fig. 6 (a), it can be seen that there is no contour line in a region near the bottom of the weld, that is, there is no large-scale upward migration of the material in this area. The height of this area is 0.6 mm. Figs. 6 b–d are magnified photos of this area, in which (b) is the root photo, (c) as the advancing side photo, (d) for the retreating side photo. The advancing side is the equiaxed zone, the back side is the heat affected zone, and the root is a hybrid zone between the equiaxed and the heat affected areas, and there is a "S" weakness connection defect. These results indicate that the material near the root of the weld is not stirred by a probe, and the end of probe presses the material downward. Most of the materials migrate in the direction of the advancing side and lead to the equiaxed crystal near the advancing side. Although the gap of the root weld is affected by thermal effect, it has disappeared, but no metallurgical connection has been formed, resulting in weak connection defects. This defect can slightly reduce the tensile strength of the weld, but the most serious is to reduce the back bending property of the weld. The existing research results show that the weak connection has a great influence on the fatigue performance of the joint, which greatly reduces the fatigue strength of the joint, and often becomes the starting point of the fatigue crack.

Fig. 6. Metallographic photo of the weld root of №1 specimen. a) full weld appearance; b) root part magnification; c) retreating side magnification; d) advancing side magnification.

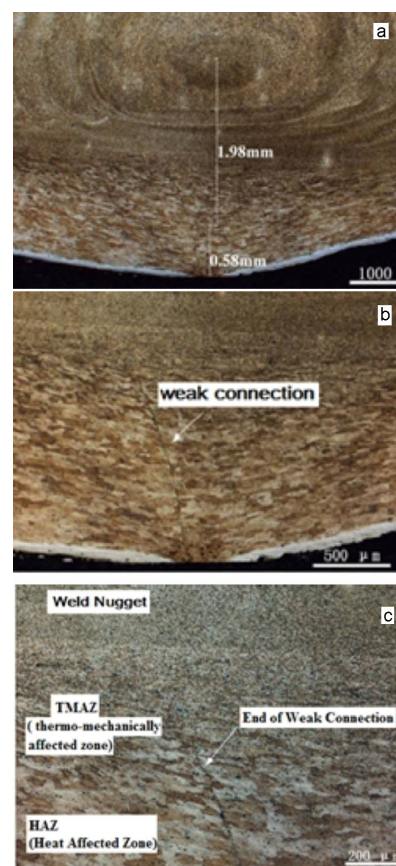
Fig. 7. is the microstructure pattern of the weld root of №3 specimen.

From the root image of Fig. 7 a, it can be seen that a large number of heat affected zone tissues appear at the weld root, and among which weak connections also found.

Amplification near the end of weak connection is shown in Fig. 7 b. It can be seen that the weld root is distributed up by the HAZ (heat affected zone), the TMAZ (thermo-mechanically affected zone) and the nugget zone (weld nugget), and the micro cracks are terminated in the TMAZ. From the above mechanical performance test, it can be concluded that the performance of №3 welded joint is the worst, and this micro cracks should be an important reason for its sharp decline in performance. This sample is used in shoe plate slotting welding procedure, the slot depth of 0.6 mm, by ball cutter. It is shown from Fig. 7 c that the microstructure of the root material of the weld appears to show the weld heat affected zone morphology, and the weak connection is offset to the advancing side by the vertical upward direction, which indicates that

Fig. 7. Microstructure photo of the weld root of 3# specimen. a) root image, b) amplification near the end of weak connection, c) microstructure amplification of the weld root.

the back material of the weld is moved down to the empty slot position of the supporting plate rapidly under the action of the forging force of the probe. With the mechanical agitation of the probe, the mass transfer of the material does not occurred, the position of lack of penetration is the position of the original weld, the transfer of the material can be reacted with left offset of lack of penetration. When the weak connection defect to the heat affected zone showed that the material have been migrated on a large scale, the weak connection completely disappeared. It is measured that the weak connection length is 1.2 mm, the 0.6 mm of the slot depth is removed, the weak connection still has 0.6 mm, and the common friction welding weld seam with the same welding condition has no weak connection defect, which shows that the shoe plate slotting friction stir welding procedure has the disadvantage in increasing the penetration and eliminating the weak connection defects.

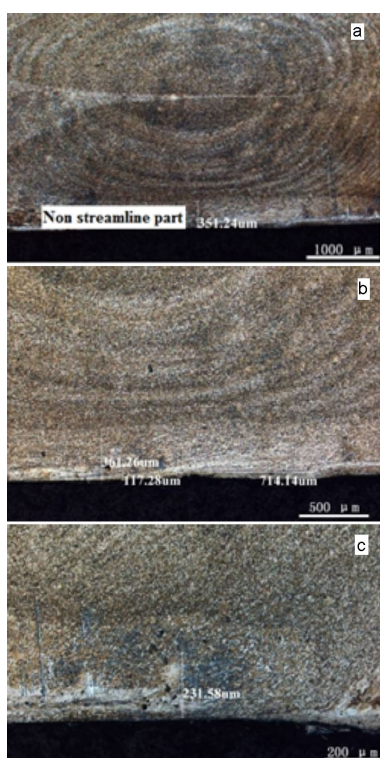
Fig. 8. Metallographic photo of the weld root of №4 specimen; a) macroscopic appearance of weld nugget; b) root of the weld; (c) magnifying photo of long strip solid solution.

Fig. 8 is the metallographic photograph of the weld root of 4# specimen, in which (a) is the macroscopic appearance of the whole weld nugget, showing the "onion" shape. There is still a zone without "onion" pattern at the root of the weld as 1# sample. Its thickness is 0.36mm and the thickness of 1# is smaller than 0.24mm, which illustrates the material under this kind of procedure. The migration range is extended to the depth direction. (b) for the root region, its tissue is more homogeneous than that of 1#. There is no structure of the heat affected zone in the advancing side and the retreating side, but there is a long strip of white phase at the bottom of the plate. The white phase spectrum analysis data shows that the solid solution organization with high Al content.

Fig. 8 c is magnified photographs of the solid solution of the bottom strip. It is found that the thickness of the solid solution is about 0.12 mm, the maximum edge reaches 0.23 mm, and the upper layer of the solid solution is a fine equiaxed structure. Scanning near the root of the white solid solution revealed that there existed horizontal weak connection defects near the phase.

The №4 sample is used in the form of root slotting, because there is space on the back and the straight line disappears. In the process of friction stir welding, the material from the solid circle extrusion zone at the end of the probe can fill here quickly. This is the reason why there is no "S" weak connection and no heat affected structure in the retreat side of the specimen. However, because of the direct contact with the shoe plate, the heat dissipation is fast, the temperature of the extruded material in this area is rapidly reduced, and the solid solution structure is formed in a strip shape, and the weak connection defect is easily formed because of the lack of heat. It is shown from the previous performance test that because the weld root has a wide equiaxed grain region, the plasticity is better and the back bending performance is better, but the tensile property is 2.3% lower than that of the back plate type weld, because of the long strip solid solution with the thickness of 0.12 mm and the existence of horizontal weak connections.

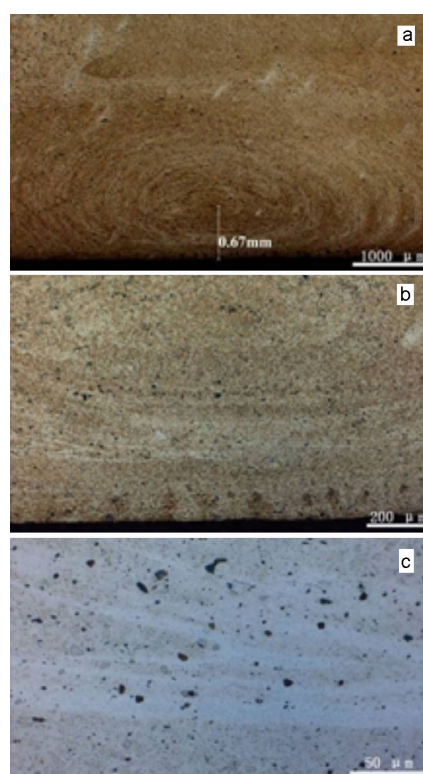
Fig. 9. Metallographic photo of the weld root of №2 specimen.

Fig. 9 is the metallographic photo of the weld root of the №2 specimen. Compared with the other welding procedures, the ring of the №2 weld is the most flat and the center distance of the ring is the smallest distance, 0.67 mm. This is the result of a long mixing probe, that is, the whole weld is in the weld nugget area and the weld nugget area is still a typical "onion" like structure and made up of black and white rings. Through the energy spectrum analysis, the white ring is an aluminum based solid solution with low Cu content (1.23%), while the black ring is an aluminum based solid solution containing a large amount of Cu (3.46%).

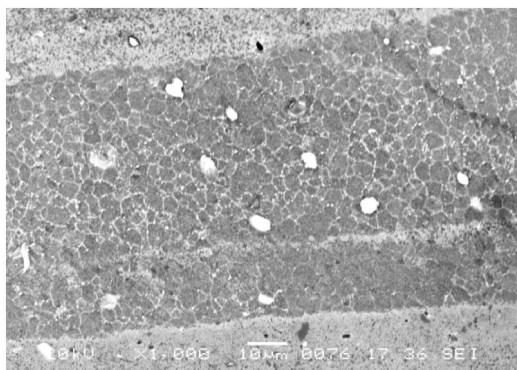
Fig. 10. Scanning photo near the streamline stripe of №2 specimen.

Fig. 10 is scanned photographs of the vicinity of streamline stripes. It can be seen that there are precipitates in the grain boundaries of equiaxed grains, and there are blocky precipitates. The black granular dispersed phase is distributed throughout the weld area and it is ellipsoidal (CuAl_2) phase by energy spectrum analysis. Compared with the above three kinds of weld beads, the precipitated phase in the weld θ (CuAl_2) is obviously larger. This is a probe with a long mixing needle, and the heat transfer effect between the weld plate and the supporting plate is weakened because of the back plate. The increase of heat in the weld leads to the increase of the precipitate phase in the weld nugget and the plastic deterioration of the material in the weld nugget area. It is also the reason for the decline of the back bending properties of №2 specimen.
