DAMAGING OF PURE TUNGSTEN WITH DIFFERENT MICROSTRUCTURE UNDER SEQUENTIAL QSPA AND LHD PLASMA LOADS

The cracking thresholds were evaluated for tungsten samples with different microstructure in the course of QSPA Kh-50 repetitive plasma loads. No damage has been observed on the exposed surfaces under 0.1 MJ/m². Nevertheless, cracks were detected in the bulk of irradiated tungsten (with longitudinal grain orientation). Increasing heat load up to 0.2 MJ/m² caused the damaging of all types of tungsten targets. The observed cracks propagate to the bulk mainly transversely and parallel to the irradiated surface. The effect of the subsequent exposure with LHD divertor plasma on the tungsten samples was analyzed. The obtained results are discussed.

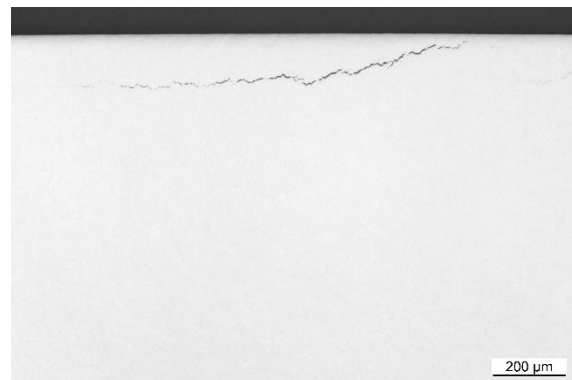
Fig. 2. Optical microscope image of the crack penetration in the metallographic cross section of L sample exposed with the plasma load of 0.1 MJ/m^2 at $T_{\text{base}} = 400^\circ\text{C}$

independently on their microstructure (Fig. 1). Only slightly increasing surface roughness is observed ($R_a \leq 1.2 \mu\text{m}$). The metallographic analysis shows the cracks penetration to the bulk of exposed tungsten sample with longitudinal orientation (Fig. 2). The cracks propagate to the material in parallel to the sample surface. The maximum crack depth is about $200 \mu\text{m}$.

Features of the pre-heated L tungsten samples need to be discussed in more detail. As it is seen from the metallographic cross section (Figs. 2, 6,b), QSPA exposures with heat load of 0.1 MJ/m^2 and 0.2 MJ/m^2 lead to crack propagation in the near-surface layer parallel to the surface. Deep cracks are longer ($> 1\text{mm}$) in both cases. The maximum depth of cracks was almost 200 μm for the heat load of 0.1 and 600 μm for 0.2 MJ/m^2 . All cracks originate in the near-surface layer and further grow far into depth. Cracks change their orientation during propagation deviating from their initial path.
