Experimental and Numerical Analysis of Normal and Lateral High-Velocity Impacts on Carbon Fiber-Reinforced Polymer Laminates

This paper examines the effects of normal and lateral high-speed impacts on carbon fiber-reinforced polymer laminates. Experimental tests were conducted at varying velocities (120–200 m/s), and the differing damage modes between normal and lateral impacts were analyzed. Dynamic finite element analysis was performed to simulate the damage process using the finite element software ABAQUS. The simulation shows a good correlation with the experimental results.

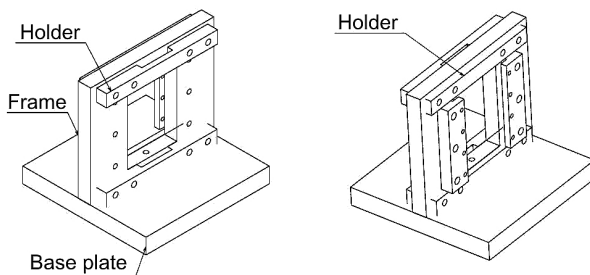
Fig. 2. Test fixture.

1. **Procedure.** We conducted a high-velocity impact test for a CFRP laminate made by Beijing Aeronautical Manufacturing Technology Research Institute. The CFRP laminate possessed a T300 high-strength carbon fiber as reinforcing fiber and a QY8911 resin as matrix. The stacking sequence was $[(45/0/-45/90)_4/0]_s$. Figure 1 indicated the stacking angles. Its dimensions were 150 mm long, 45 mm wide, and approximately 5 mm thick. As shown in Fig. 2, the specimen was fastened by bolts at both ends by the frame plate and holder plate.

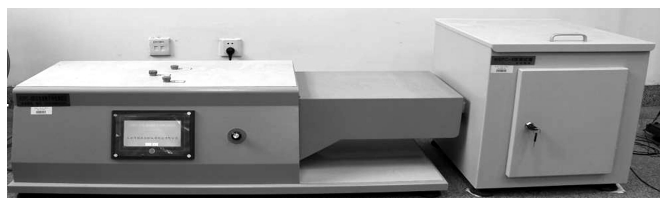
Figure 3 shows the ballistic impact testing machine created by the Ruijie Company. It was a compressed-air cannon comprised of a gas cylinder, an air tank, a launching valve, and a laser velocimeter. It used compressed gas to accelerate a spherical projectile. The bore was smooth, with a caliber of 6 mm and a maximum design speed of 200 m/s. The spherical projectile was made of bearing steel, was 6 mm in diameter, and weighed 0.85 g.

Fig. 3. Ballistic impact testing machine.

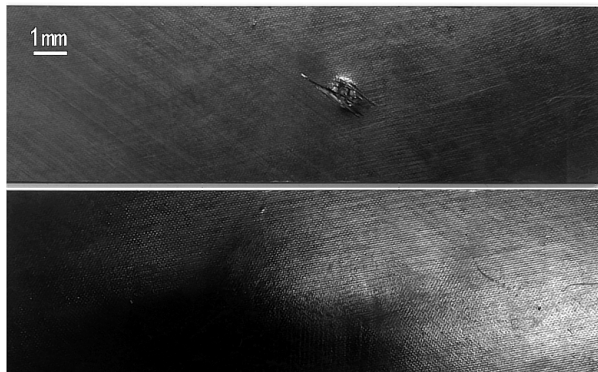
2. **Results.** Figure 4 displays typical surface damage for normal impacts. Figures 5 and 6 show lateral impact damage (200 m/s impact speed). No specimen was perforated at the maximum impact speed (200 m/s). For the specimen that suffered the normal impact, the projectile collision generated a crater on the obverse surface. Cracks extended along the fiber direction out from the crater; there was no obvious damage on the reverse side. For the specimen that suffered the lateral impact, there was also a crater on the specimen's side. The impact was deeper than the normal-impact crater. There are protrusions on both surfaces with the matrix crack; the crack extended along the fiber direction out from the crater. The crack length was longer in the lateral impact than in the normal impact.

Fig. 4. Typical surface damage from a normal impact (up side and down side).

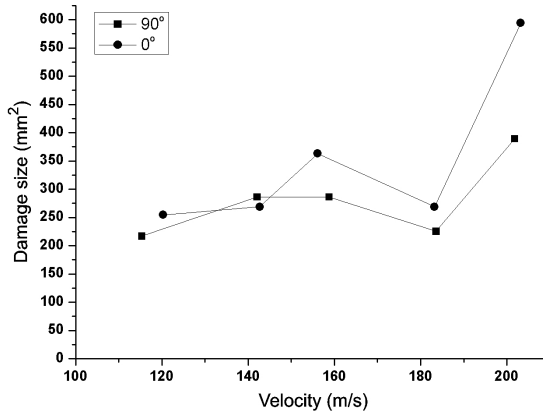
Figure 9 shows that the damage size changes with speed for the two impact styles; the damage size for the normal impact is slightly larger than that of the lateral-impact.

Fig. 9. Damage size of impact.

2. The normal impact damage size was slightly larger than the lateral-impact damage size, but the maximum damage distance for the lateral impact was much larger than that of the normal impact. It is surmised that the response time of the lateral-impact load was longer than the normal-impact load response time, and the longitudinal stress wave spread faster than the transverse wave, so the stress waves spread farther.

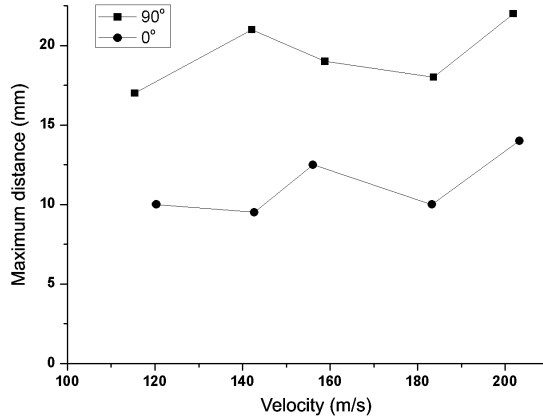
Figure 10 shows that the maximum damage distance changes with speed for both impact styles. The damage region for the lateral impact is roughly semicircular, so the maximum damage distance for the lateral impact is much larger than that of the normal impact. This is true despite the fact that the damage size for the normal impact is slightly bigger than that of the lateral impact.

Fig. 10. Maximum damage distance of impact.

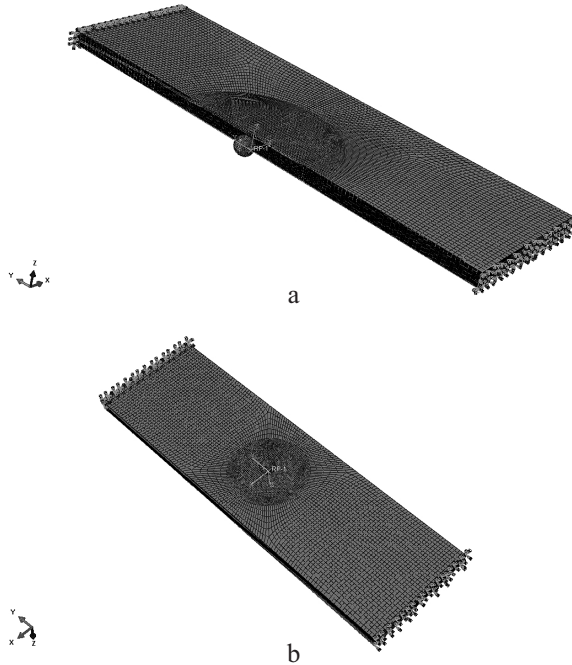
Figure 11 shows the numerical model used in this study. The stacking sequence was $[(45/0/-45/90)_4/0]_s$; the dimensions were $150 \times 45 \times 5$ mm, as with the specimen.

Fig. 11. Numerical model of lateral (a) and normal (b) impacts.

Figure 12 is a numerical model of normal impact to contrast with this study, the simulation method as same as lateral impact. Eight linear reduced integration node elements were employed to express the laminate; one ply was modeled by one element. The model was fixed at both ends. A cohesive element was introduced between every two plies. The unit densities near the point of impact were denser than in other parts. The elements judged as fiber tensile failures were ignored.

The diameter of the modeled spherical projectile was 6 mm with a density of 7800 kg/m^3 . It was modeled as a rigid surface, and the hard contacts were considered between the projectile and the laminates. Friction was not considered.

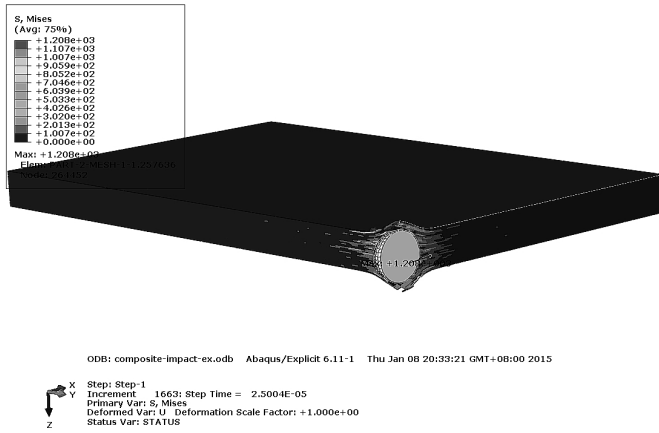
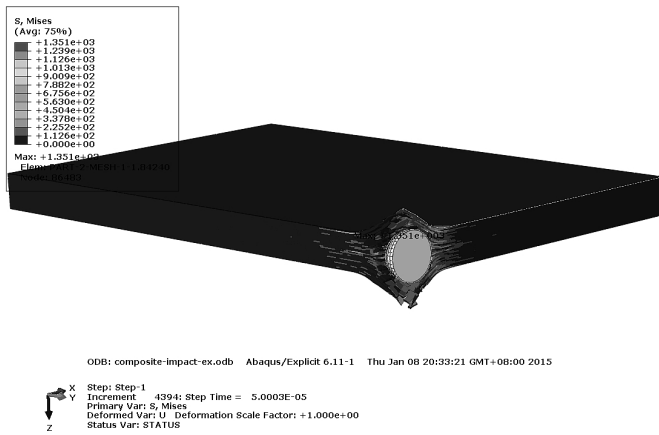
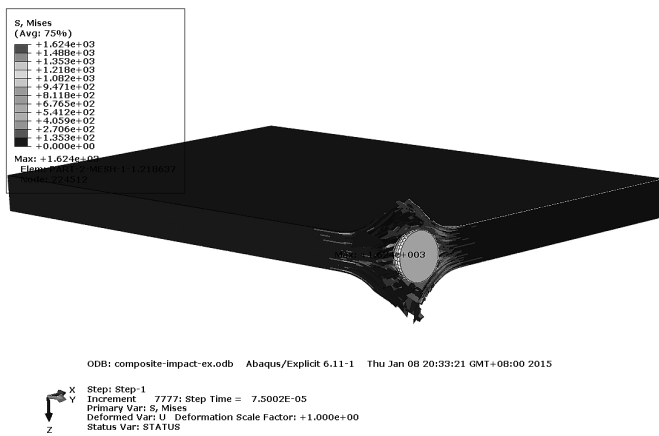
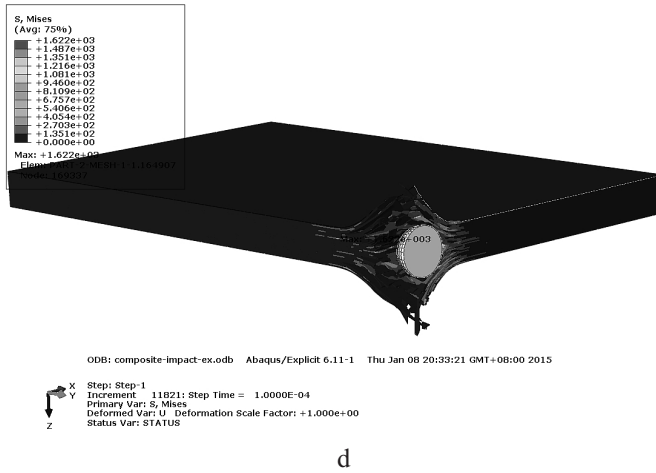
Fig. 12. Numerical nephogram of Mises stress of lateral impact: (a) $t = 0.025$ ms; (b) $t = 0.05$ ms; (c) $t = 0.075$ ms; (d) $t = 0.1$ ms.

Figure 12 shows the stress extension trend. Near the impact point, the projectile impact caused fiber failure and a crater. Extruding the outer ply projecting outward, the projections were symmetrical from top to bottom. It can be find that the stress extends far away from the impact point. Along with time growth, at plies of 0 and 90° , the stress propagation distances along the fiber direction are much longer than in other plies; this suggests that stress waves spread faster along the fiber direction.

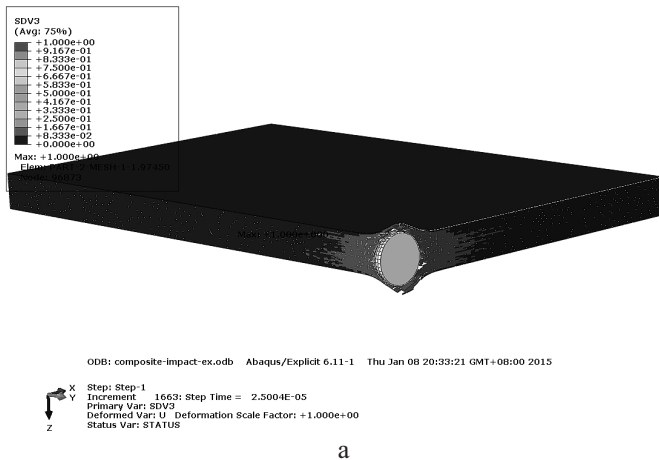
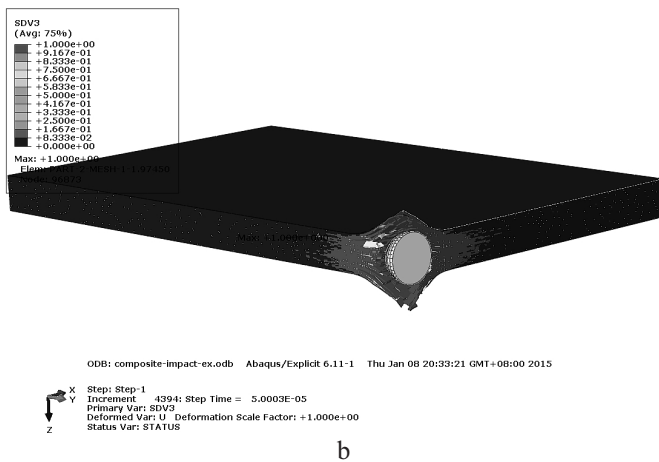
Figure 13 shows that matrix cracking and delamination extruded from the impact point and the damage size increased with lateral impact time.

Fig. 13. Numerical nephogram of matrix cracking and delamination of lateral impact: (a) $t = 0.025$ ms; (b) $t = 0.05$ ms; (c) $t = 0.075$ ms; (d) $t = 0.1$ ms.

Figures 13 and 14 demonstrate that cracks were bigger if the region was close to the impact point, regardless of the impact type and damage size. Damage areas for delamination

increased gradually from the impact point to the opposite surface, which is consistent with findings [28]. Delamination and fiber failure always happened in conjunction with matrix cracking. The damage size of matrix cracking was always larger than the delamination damage size at the same ply.
